Measurement Setup

Deye SUN-30K-SG01HP3-EU-BM3 (signal island mode activated, VDE4105 setup)

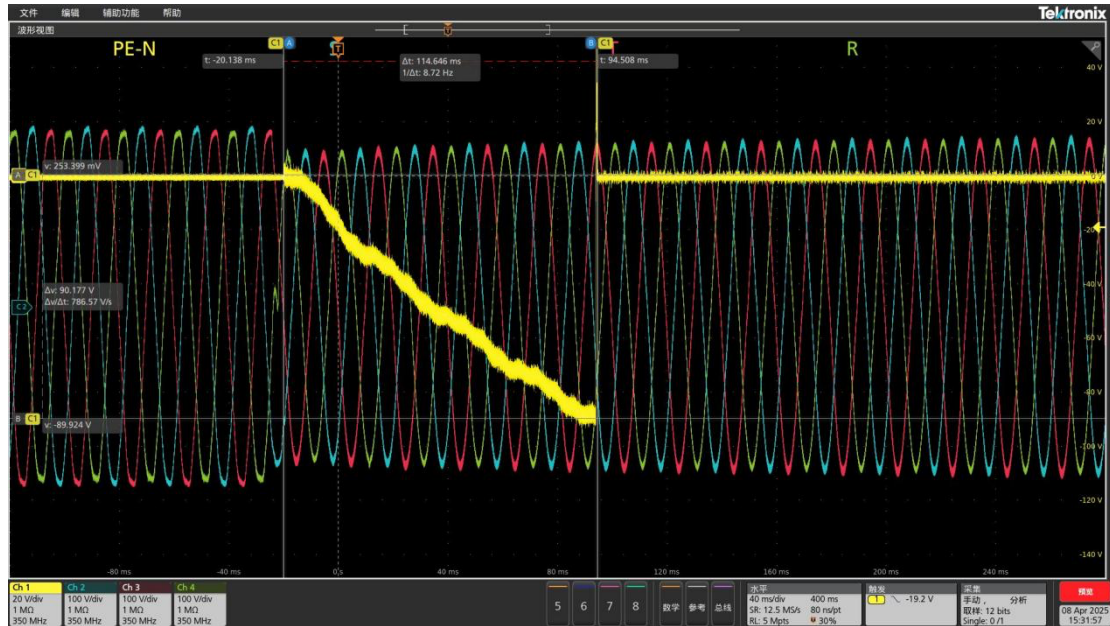
Figure1-firmware: MAIN 1086

Main 1086: PE_N relay closing delayed about 114ms. And the voltage rised to 89.9V

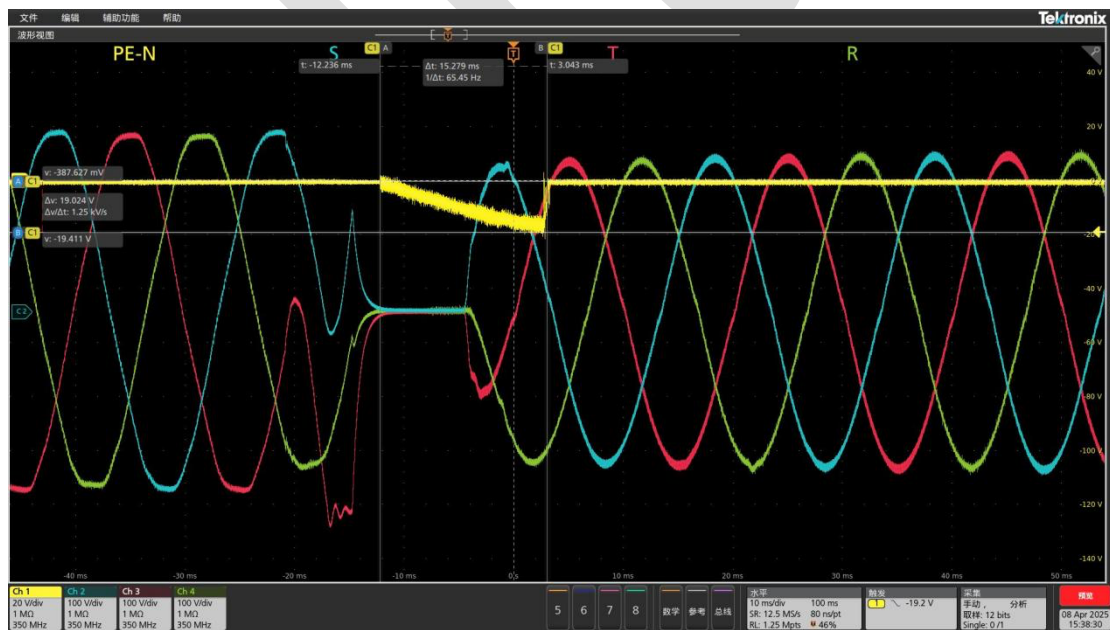
Figure2-firmware: MAIN F096

Main 1096: PE_N relay closing delayed about 12.2ms. And the voltage rised to 19.4V

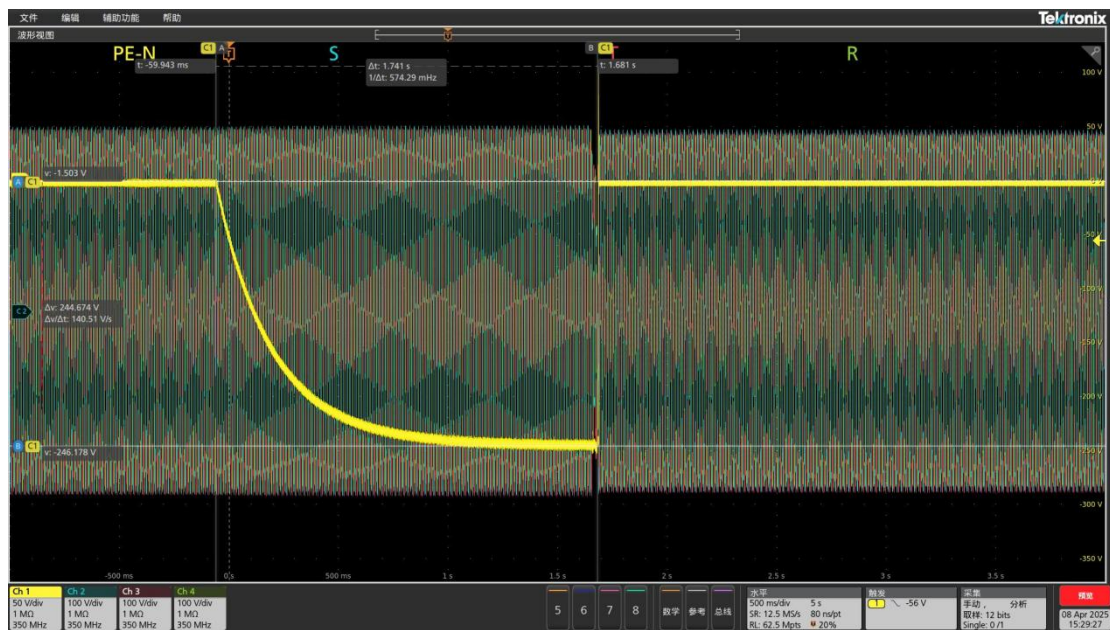
Figure3-firmware: MAIN 1086

Main 1086: PE_N relay opened 1.74s, voltage 246V

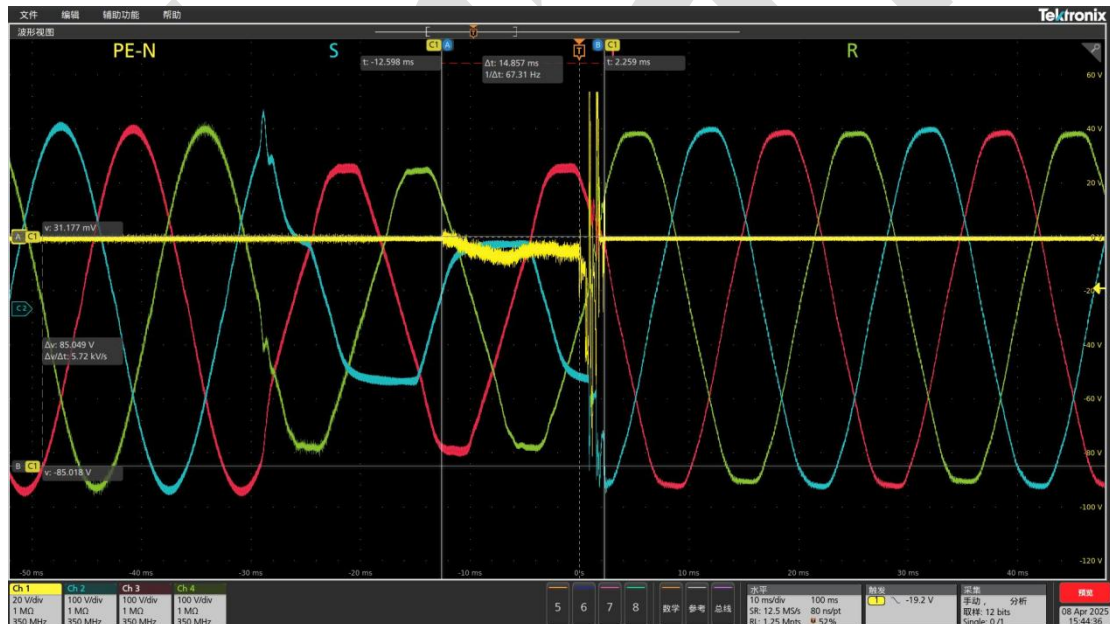
Figure4-firmware: MAIN F096

Main 1096: PE_N relay opened 14ms, voltage 20-40V(noise)

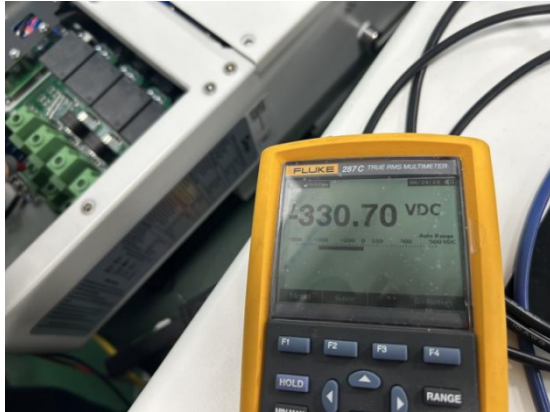
by setting 'parallel Bat1&2' option, this will cause inverter restart, at this time the load side

relay(L1 L2 L3 N) are all opened. There has a DC voltage between PE and N. this voltage was caused by leakcurrent inside of inverter (we have about 5-8M register connect between PE and N) 。

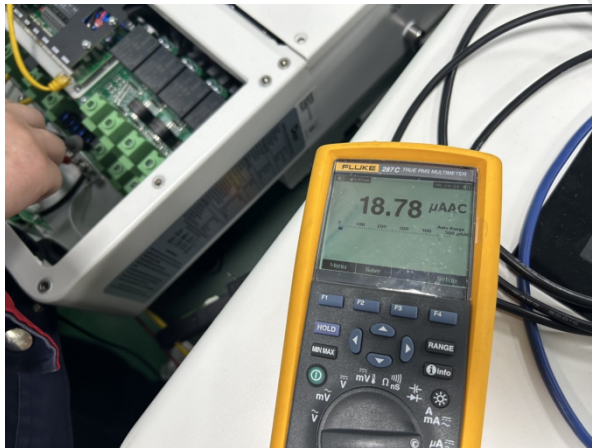
1, we connect a 500 Ω register between PE and N. voltage drop to almost zero, and the current was less than 1mA

So according IEC62109-1, the current shall not exceed 3.5mAac or 10mAdc, so when inverter standby, this voltage will not cause harm to the human body or equipment
