## READ ME

| <b>Wechselrichter</b> | <b>SI 6.0_8.0H-13 / SI 6.0_8.0H-12</b> |
| <b>FW-Version</b> | <b>Firmware Paket 3.30.37.R</b> |

<table><tr> <td><b>Software Paket</b></td><td><b>V3.30.37.R</b></td></tr></table>

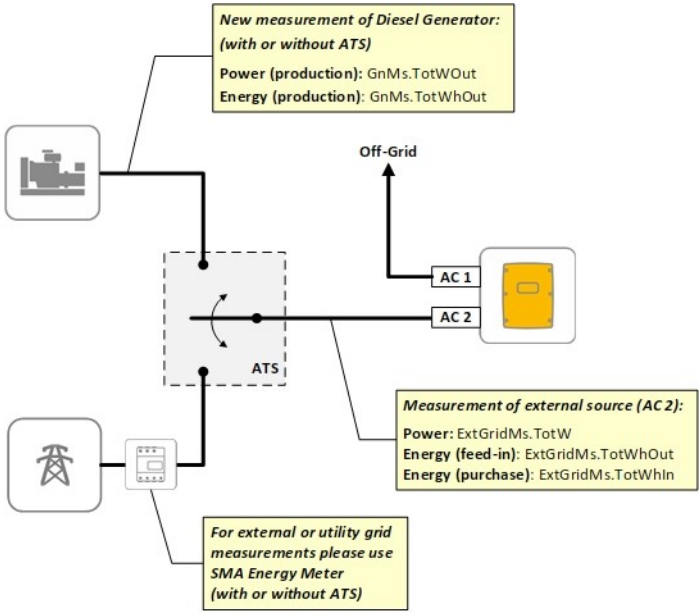
| | <p>Meter is not needed. In case you wish to monitor the grid power you need always an Energy Meter (see diagram below).</p> <p><b>New measurement of Diesel Generator:</b><br/>(with or without ATS)<br/>Power (production): GnMs.TotWOut<br/>Energy (production): GnMs.TotWhOut</p> <p><b>Off-Grid</b></p> <p><b>Measurement of external source (AC 2):</b><br/>Power: ExtGridMs.TotW<br/>Energy (feed-in): ExtGridMs.TotWhOut<br/>Energy (purchase): ExtGridMs.TotWhIn</p> <p><b>For external or utility grid measurements please use SMA Energy Meter (with or without ATS)</b></p> |

- **Separate measurement of Diesel Generators:**  
With the new firmware are available separate measurement values of Diesel Generators connected to Sunny Island or Multicluster box systems. These values can be used to visualize p. ex. manually added devices in the Sunny Portal powered by ennexOS. In this case, the additional Energy
